Below are photographs illustrating the decline of the electrical grid, as well as features of the grid that may be helpful to you as you learn about electrical pollution.

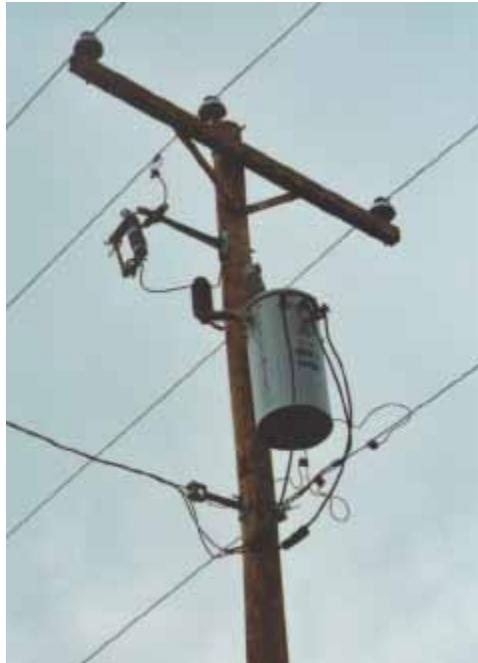
New transformer with new wires installed during the summer of 2002 - some electrical utilities are fusing their wires so that the primary neutral is not visibly larger, but the fuses are sized such that less than half the capacity of the phase wires is utilized. (this way of fixing the problem seems to be occurring only in isolated cases.)

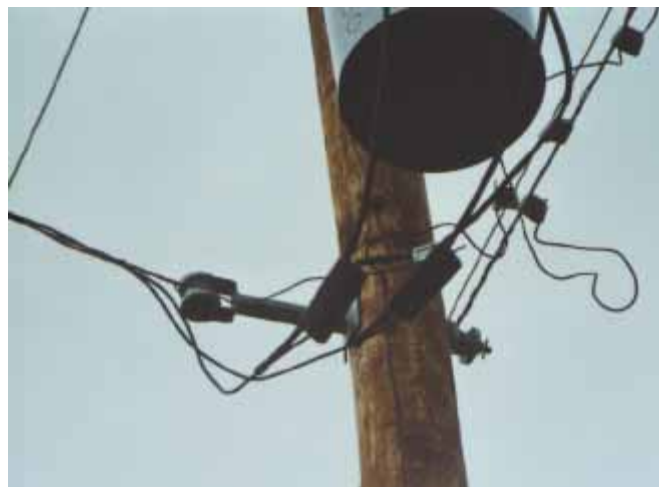
Crimp-on connectors were used to join the transformer (picuted above) to distribution wires. They are the black rectangles in the center of the photo.

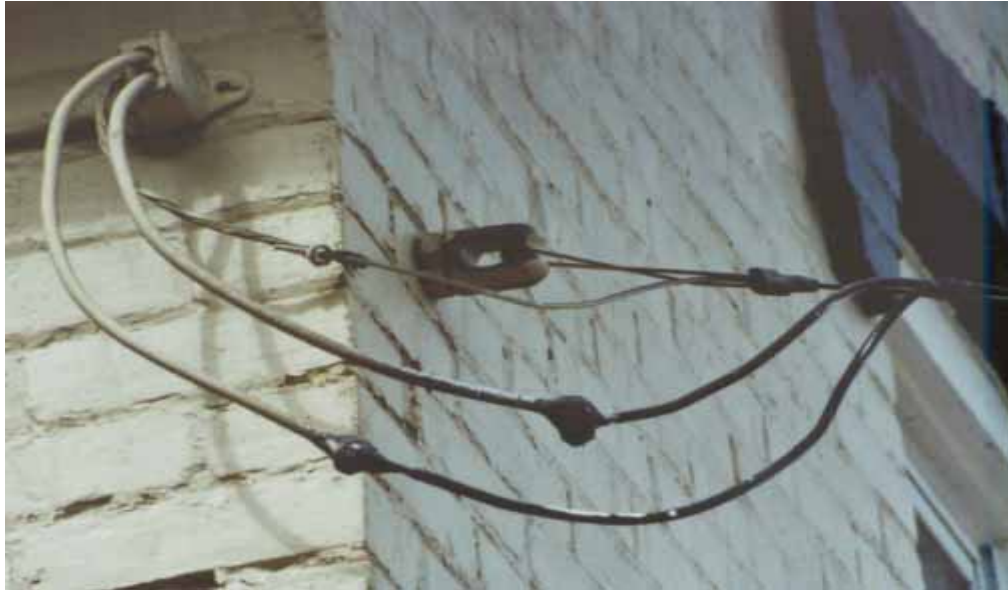
Split-bolt connectors on a utility owned house. The split-bolts themselves are not visible as they are wrapping in many layers of electrical tape for protection. The PSC in Wisconsin has not allowed the electrical utilities to use split-bolts for many years because over time they loosen up and arc.

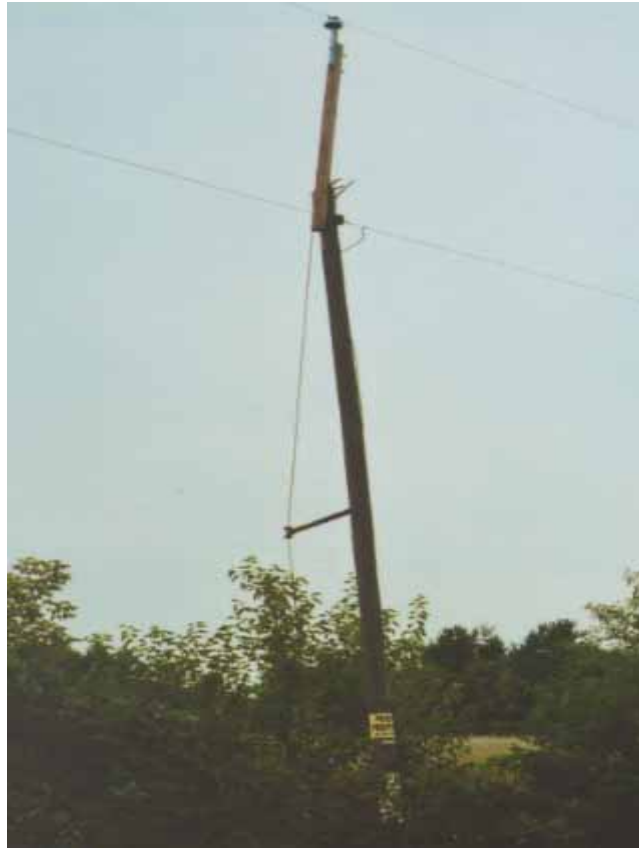
Is this the approved method of repairing broken poles?

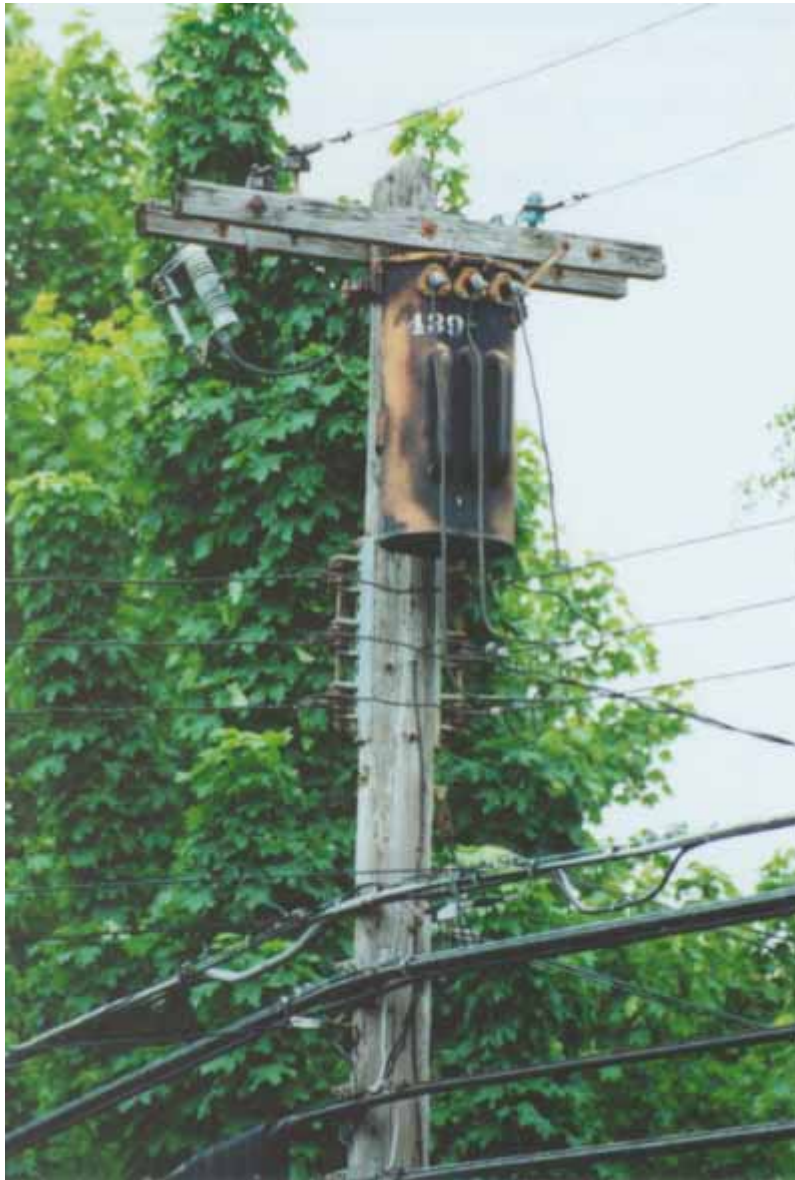
Transformer with paint showing evidence of deterioration and old-style connectors
